# BGA Shoulder Bolt Inspection

The primary goal of the inspection is to verify that the P6 BGA shoulder bolts are present (or backing out) in the locations which are readily visible during the MISSE and FPP photography tasks.

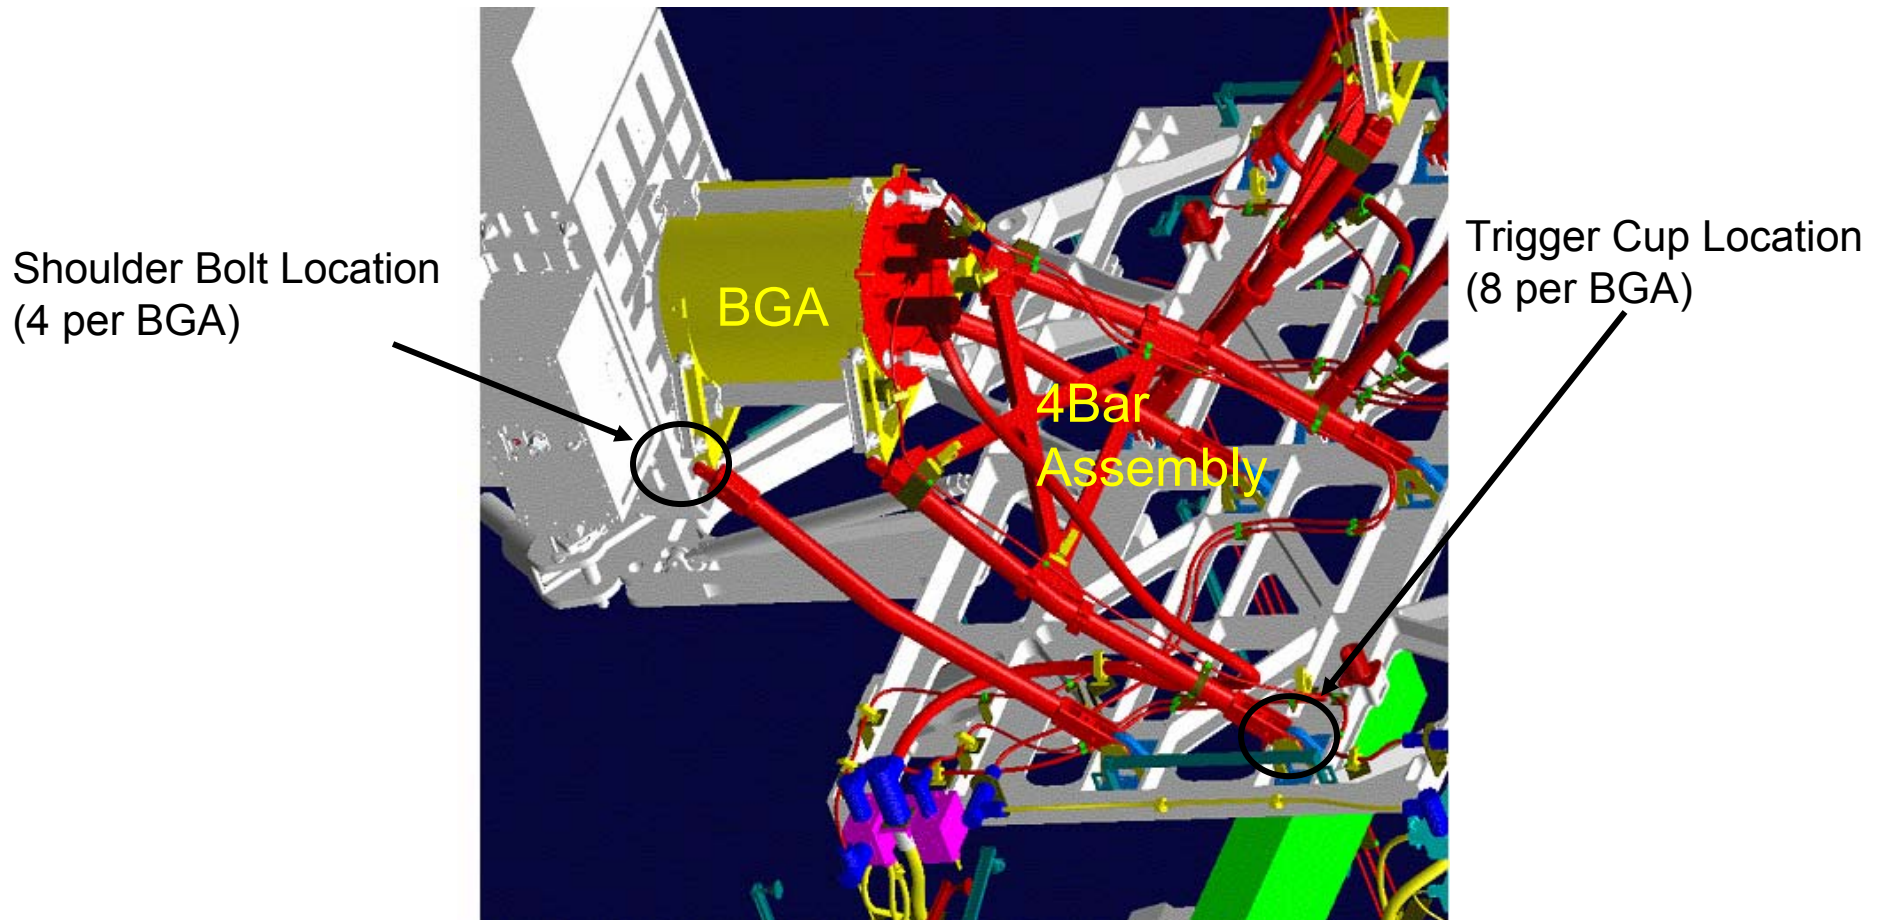
- The design on P6 has an oversized hole used on a bolt that is carrying a shear load. The bolt interface receives cyclic shear loading which can, over time, cause the bolt to back out. A future EVA will install a bolt locking device. However in the meantime, the integrity of the bolts has been inferred from photogrammetry during reboost. Photographs of the bolts will provide direct verification of their integrity.
- Photography is preferred but WVS video is acceptable
- Photographs will be taken from handrail 5307

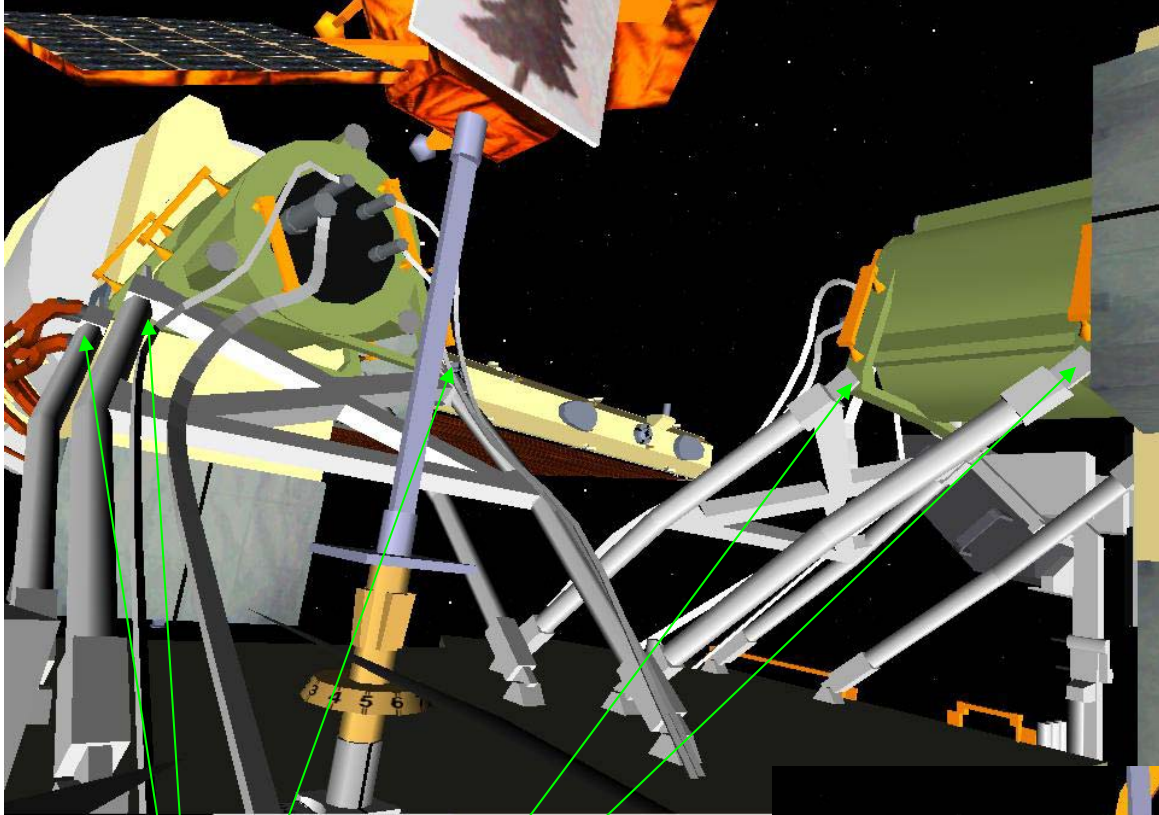
# Possible views from HR 5307

Locations of bolts  
to photograph
